Taipei, Taiwan
July 14, 1964

Revised:
Washington, D.C., USA
August 14, 1964

STRUCTURES INVESTIGATION REPORT
CONCERNING ACCIDENT TO CIVIL AIR TRANSPORT
C-46 DM, B-908, NEAR TAICHUNG, TAIWAN,
ON JUNE 20, 1964

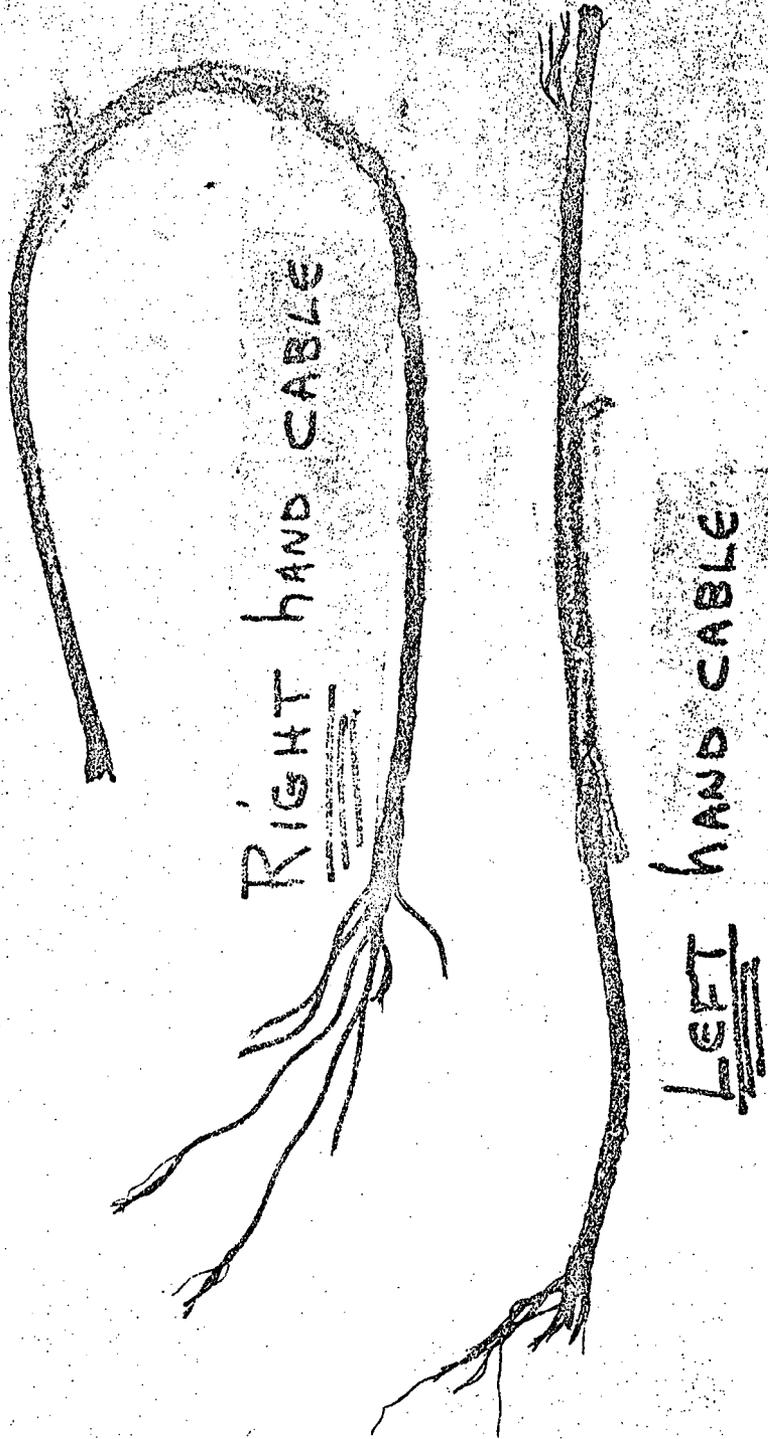
Fig. I-1

Examples of the more severe wearlike damage on the exterior wires of the other six strands are shown in Figures I-8 and I-9. This too is typical of damage due to one or a few interferences with hard surfaces at very high pressure, rather than normal service wear of a lightly loaded cable dragging repeatedly over some stationary surface.

It is possible that some of the individual wire fractures could have included fatigue cracking, with subsequent obliteration of the characteristic fracture surfaces due to moving interference with a hard surface at high pressure. However, it appears more probable that both the wire fractures and the wearlike damage on exterior wires of the cable occurred during the disintegration of the airplane on impact with the ground. No positive indication of significant wear or other unairworthy condition of this cable prior to impact of the airplane with the ground was found during this examination.
